1 **The value of a desk study for building a national river obstacle inventory**

23 This study evaluates two desk-based approaches for building an inventory of man-made river
24 obstacles. The creation of a river obstacle inventory is a logical first step in developing a
25 prioritisation process for obstacle removal and/ or modification. In this study, a desktop GIS
26 (Geographical Information System) analysis of two rivers and their tributary network was
27 undertaken, using two different approaches. The first involved analysing historical maps,
28 satellite imagery and Ordnance Survey Ireland (OSI) Discovery Series maps, and producing a
29 geo-referenced layer of all the potential river obstacles. The second involved developing a geo-
30 referenced layer of potential river obstacles based on the intersections between elements of the
31 transport network (roads and railways) and river systems. To determine the effectiveness of the
32 desk studies, the located obstacles were cross-referenced with actual obstacles verified through

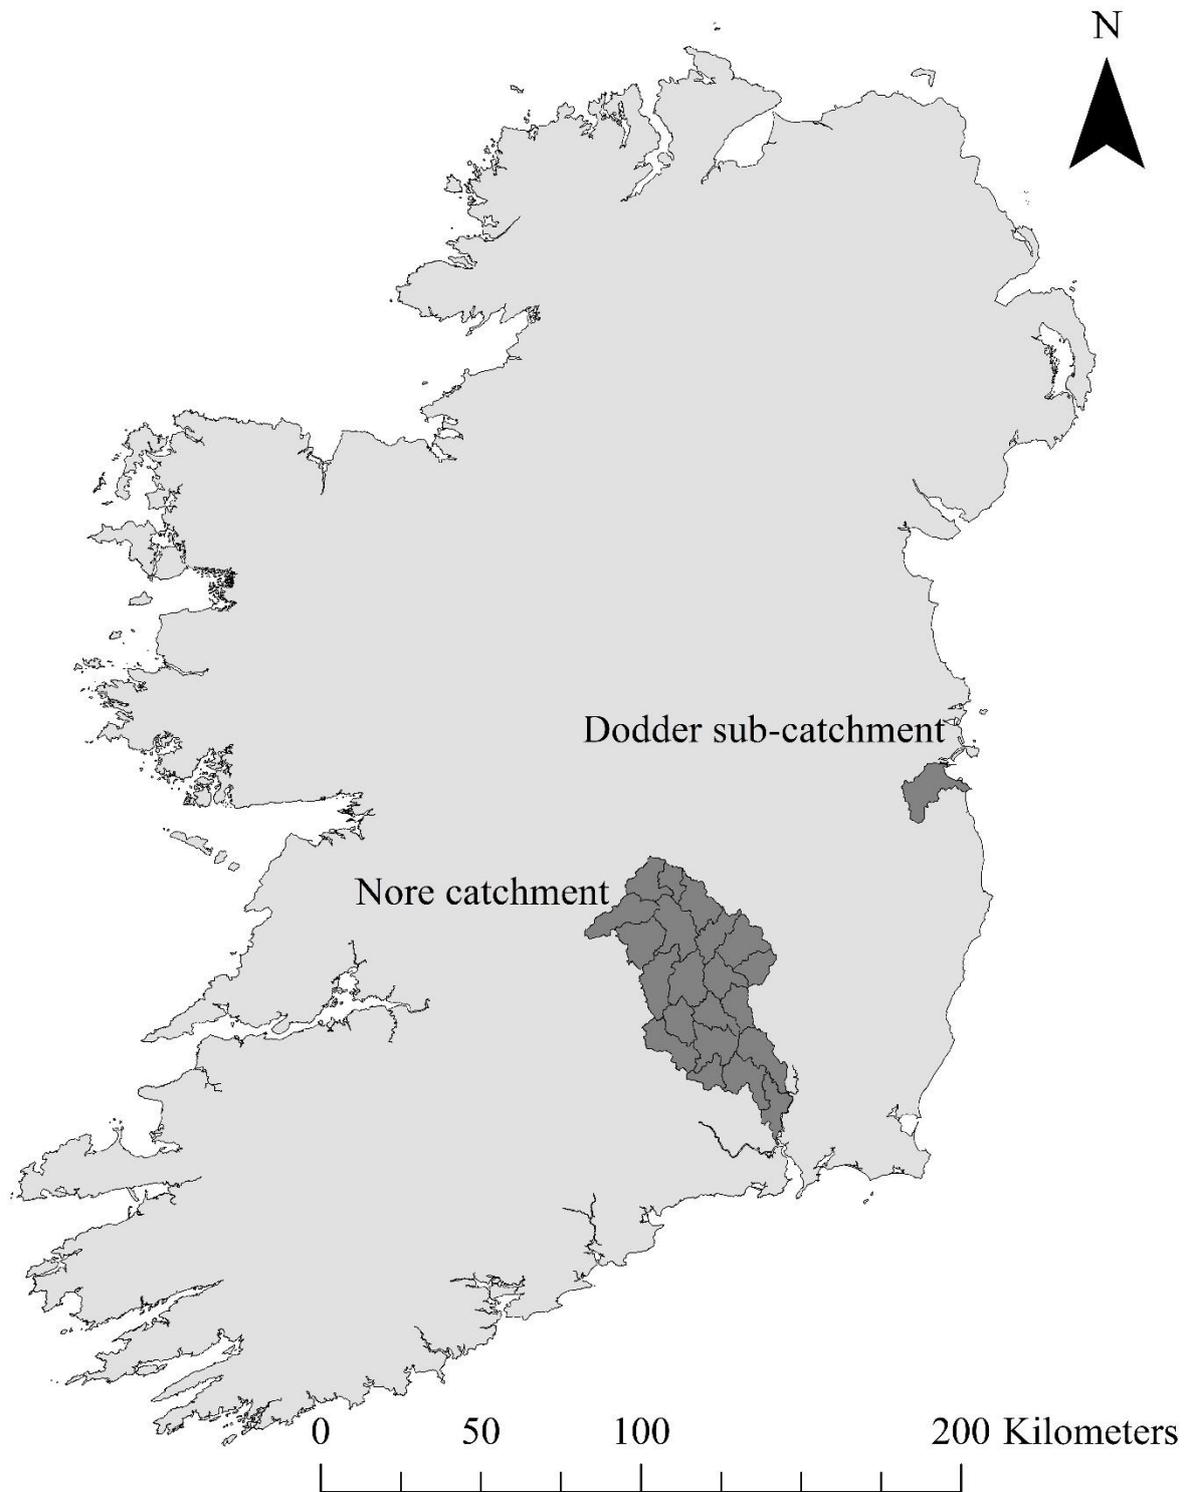
Figure 1. Map showing the location of the Nore catchment and Dodder sub-catchment in Ireland.

124 The Nore and Dodder catchments were the focus of this study (Table 1, Fig. 1). The River Nore
125 is a designated Special Area of Conservation (SAC) under the EU Habitats Directive. It is an
126 important salmon river and has previously been the focus of river obstacle research (Gargan et
127 al., 2011). Water from the main stem of the river was historically used to power water mills
128 (Hamond, 1990). The River Dodder catchment comprises a sub-catchment of the larger River

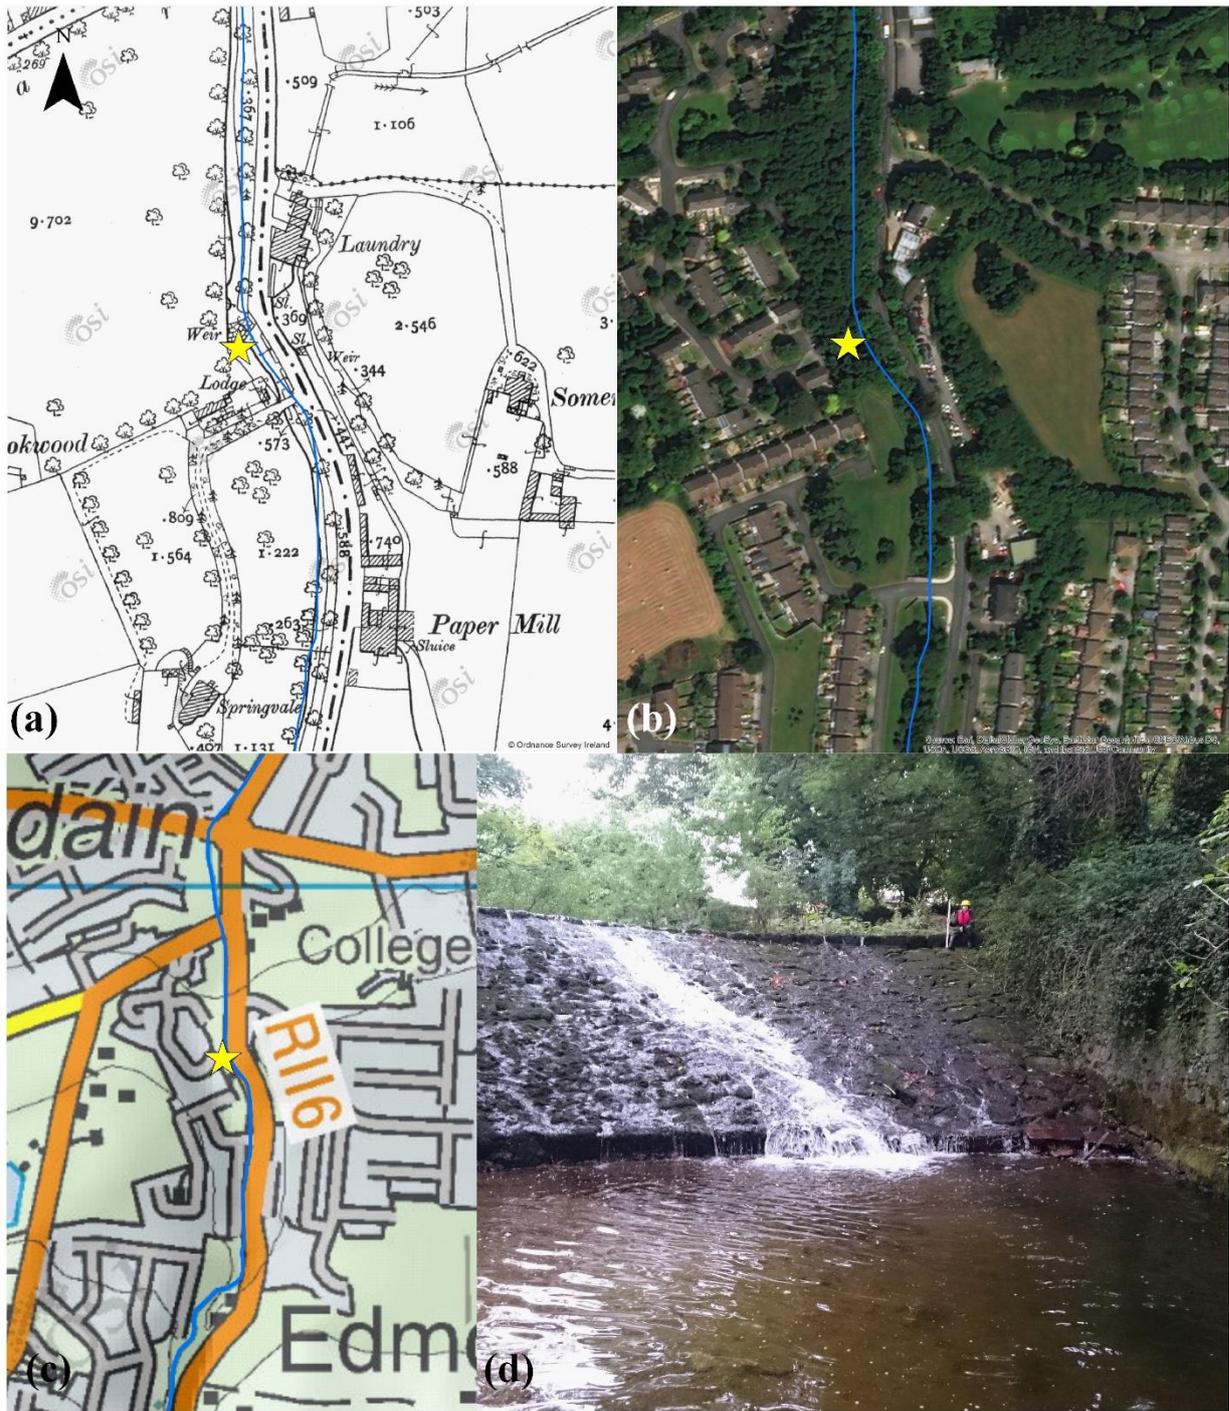
Figure 2. Examples of the map layers used to locate potential obstacles in Method I. The weir pictured in (d) and indicated with a star (a-c) was only visible on the historical 25" map layer (a). The satellite image (b) and Discovery Series map (c) were unable to indicate the obstacle.

267 Method II had a consistently lower POD compared to Method I. This shows the importance of
268 using a variety of maps to locate obstacles. The 25'' historical maps were useful for identifying
269 structures which were not on the Discovery Series maps, and which were hidden by tree cover
270 in the satellite imagery.

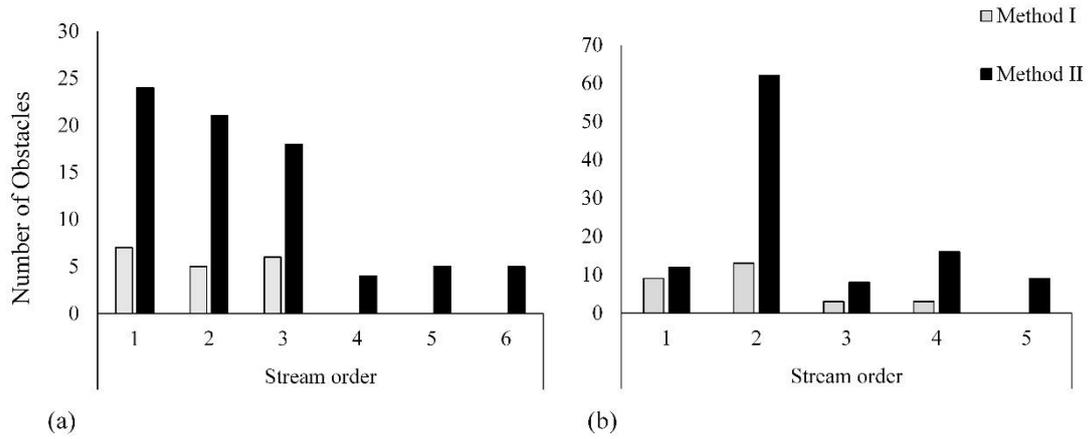
Figure 3. Graphs showing the number of missed points on (a) the Nore and (b) the Dodder catchments, and the Strahler stream order of the river segment where these were located. Columns in grey represent the misses from Method I and columns in black represent the misses from Method II.

231 A total of 19 obstacles were missed by Method I in the entire Nore catchment, and these were
232 located on 1st to 3rd order streams (Fig. 3, Fig. 4). These were mostly natural obstacles (rock
233 and bedrock formations), weirs and fords. Seventy-seven obstacles were missed via Method II,
234 and these were located on 1st to 6th order streams (Fig. 3). These misses consisted of weirs,
235 culverts, bridge aprons, bridges and natural obstacles. The FAR was high in both desk studies
236 (Table 4). Because almost 450 of the 508 obstacles on the Nore were road crossings, the
237 satellite and historical maps were not essential for their locating, as most were visible on the
238 Discovery Series maps. Only about 5% of the hits were a result of either satellite imagery or
239 historical maps alone.

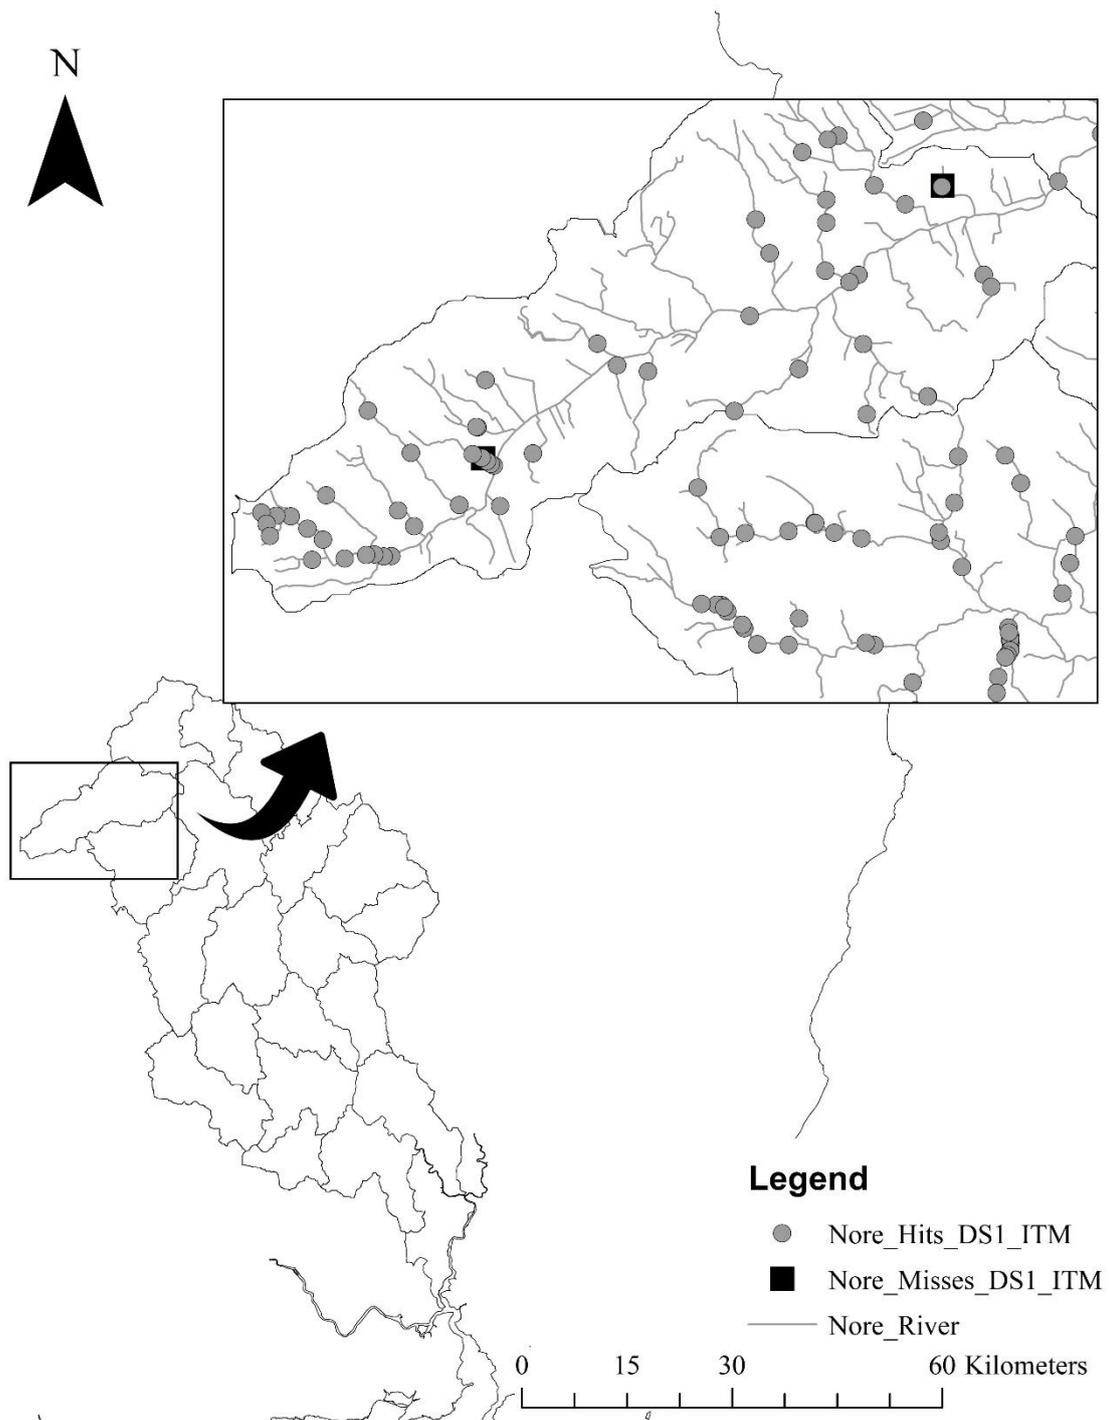
Figure 4. Map showing the locations of the hits and misses in one of the Nore sub-catchments (Nore_SC_010) from Method I.
