# Analysis of Gas Leakage during Laparoscopic Surgery

UCD School of Mechanical and Materials Engineering, University College Dublin, Dublin, Ireland

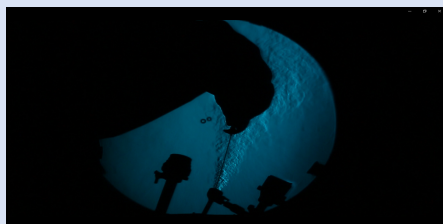
Figure 2: Raw Footage of Gas Leak recorded by Schlieren

This raw video, while precise, still runs into issues when there are obstructions to the light rays. Without further processing the raw footage will show the velocity of these moving obstructions instead of just the fluid flow, which is why further processing is required.

- Light provided by light source at angle relevant to the mirror setup
- Light bounced off of parabolic mirror which makes the rays of light all run in parallel with each other
- Parallel light beams bend around changes in density of fluid
- Light hits second mirror and focuses to a point on edge of blade
- The changes in density and light are recorded by the camera the results are shown in Figure 2

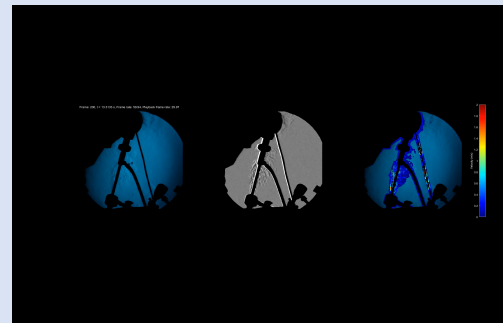
Figure 3: Video data showing a Cropping Issue

- Used for issues along the edge of the field of view of the camera
- Easiest to fix as it only requires changing the parameters of the frame within the code

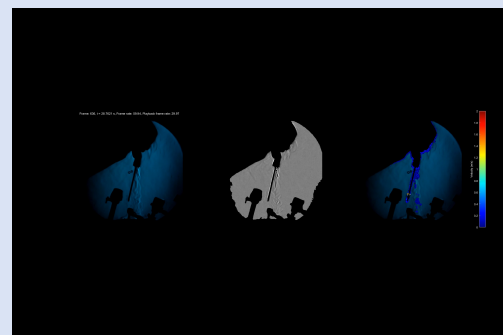
Figure 4: Video data showing a Masking Issue

- More difficult as in most cases an obstruction moves in front of the frame and creates a stray velocity vector not produced by the gas leak
- In order to fix this, a masking system must be implemented into the code
- Afterwards, the borders of this mask must be increased to remove the velocity vectors around the obstruction
